PIC16F73/74/76/77

PIC16F73/74/76/77 Rev. B1 Silicon/Data Sheet Errata

The PIC16F73/74/76/77 Rev. B1 parts you have received conform functionally to the Device Data Sheet (DS30325B), except for the anomalies described below.

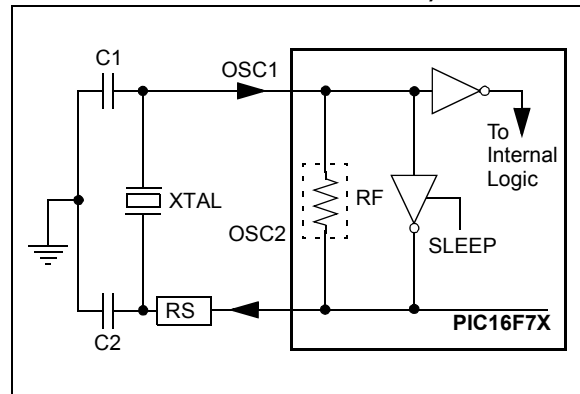
FIGURE 1: CRYSTAL/CERAMIC RESONATOR OPERATION (HS, XT OR LP OSC CONFIGURATION)

3. Module: Oscillator (HS mode)

When resonators above 2 MHz are used, the HS mode oscillator is required to ensure reliable operation. HS mode oscillator drive at frequencies from 2 MHz to 4 MHz is often excessive, resulting in the amplitude of the oscillator waveform exceeding V_{DD} and V_{SS} . In such cases, the waveform may experience distortion as ESD protection devices begin to operate on the OSC1 and OSC2 pins. This distortion appears as a non-sinusoidal waveform or clipping, and can generate substantial harmonics that may create excessive noise in the application.

The gain of the oscillator should be reduced by inserting a series resistance between the OSC2 pin and the resonator/capacitor as shown in the data sheet (see Figure 1). The value of the series resistance is dependant on V_{DD} , resonator frequency, and temperature; however, 330 ohms has been used as a good starting point for evaluation.

This change will not affect operation of future revisions of silicon as long as HS mode is selected.
